PURPOSE OF THE BLIGHT AND SUBSTANDARD STUDY

The purpose of this Blight and Substandard study is to examine existing conditions within the city of Fort Calhoun that comply with the Nebraska Community Redevelopment Act. This study has been commissioned by the City of Fort Calhoun for potential future redevelopment activity. The area is within the heart of the community and contains the downtown district.

BLIGHT AND SUBSTANDARD ELIGIBILITY STUDY

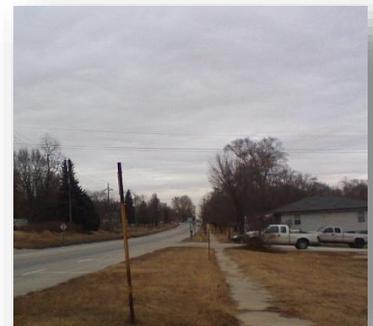
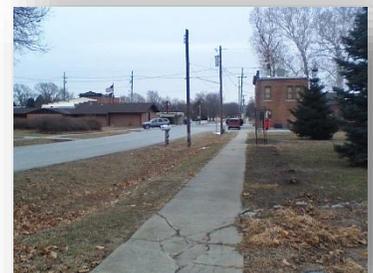
Deteriorating is defined as any vertical heaving, concrete breakup of the walking surface.

Missing is defined as not present or unseen due to long-term sediment build-up.

Within the study area there is approximately 35,050 lineal feet of area where sidewalk could or should be located. After reviewing the conditions in the field, the following is how the sidewalk conditions breakdown within the study area:

- 3,666(10.5%) lineal feet of adequate sidewalk
- 9,186(26.2%) lineal feet of deteriorating sidewalk
- 22,194(63.3%) lineal feet of no sidewalk.

Overall, there is nearly 90% of the area that either has deteriorating or no sidewalk to allow for safe pedestrian movement. There is no sidewalk present in over 63% of the study area does not have safe accessibility to pedestrian traffic.

Due to the large amount of missing sidewalk, the lack of and condition of the sidewalk is a direct contributing factor.

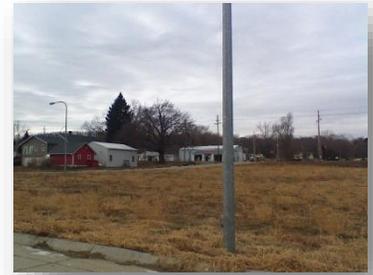
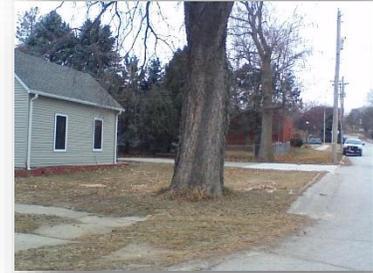
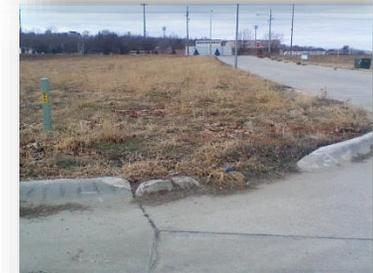
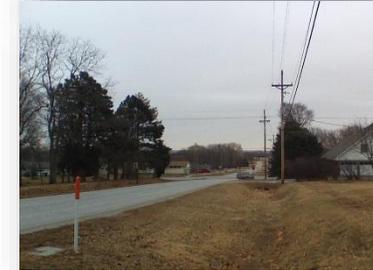
Deteriorating is defined as any evidence of breakage/chipping away at joints and horizontal surfaces. In addition, any heaving or breakage along the gutter portion of the system.

- 6,637 (16.6%) lineal feet of adequate curb and gutter
- 12,117 (30.4%) lineal feet of deteriorating curb and gutter
- 21,137 (53.0%) lineal feet of no curb and gutter or rural section.

The study area has 83.4% of the curb and gutters in either a deteriorating state or not constructed and the streets are designed as rural section streets. See Figures 5 for the locations of these curb and gutter.

The photos to the immediate right show some of the deteriorating conditions found within the study area.

Due to the large amount of deteriorating and missing curb and gutter, the curb and gutter condition would be a direct contributing factor.

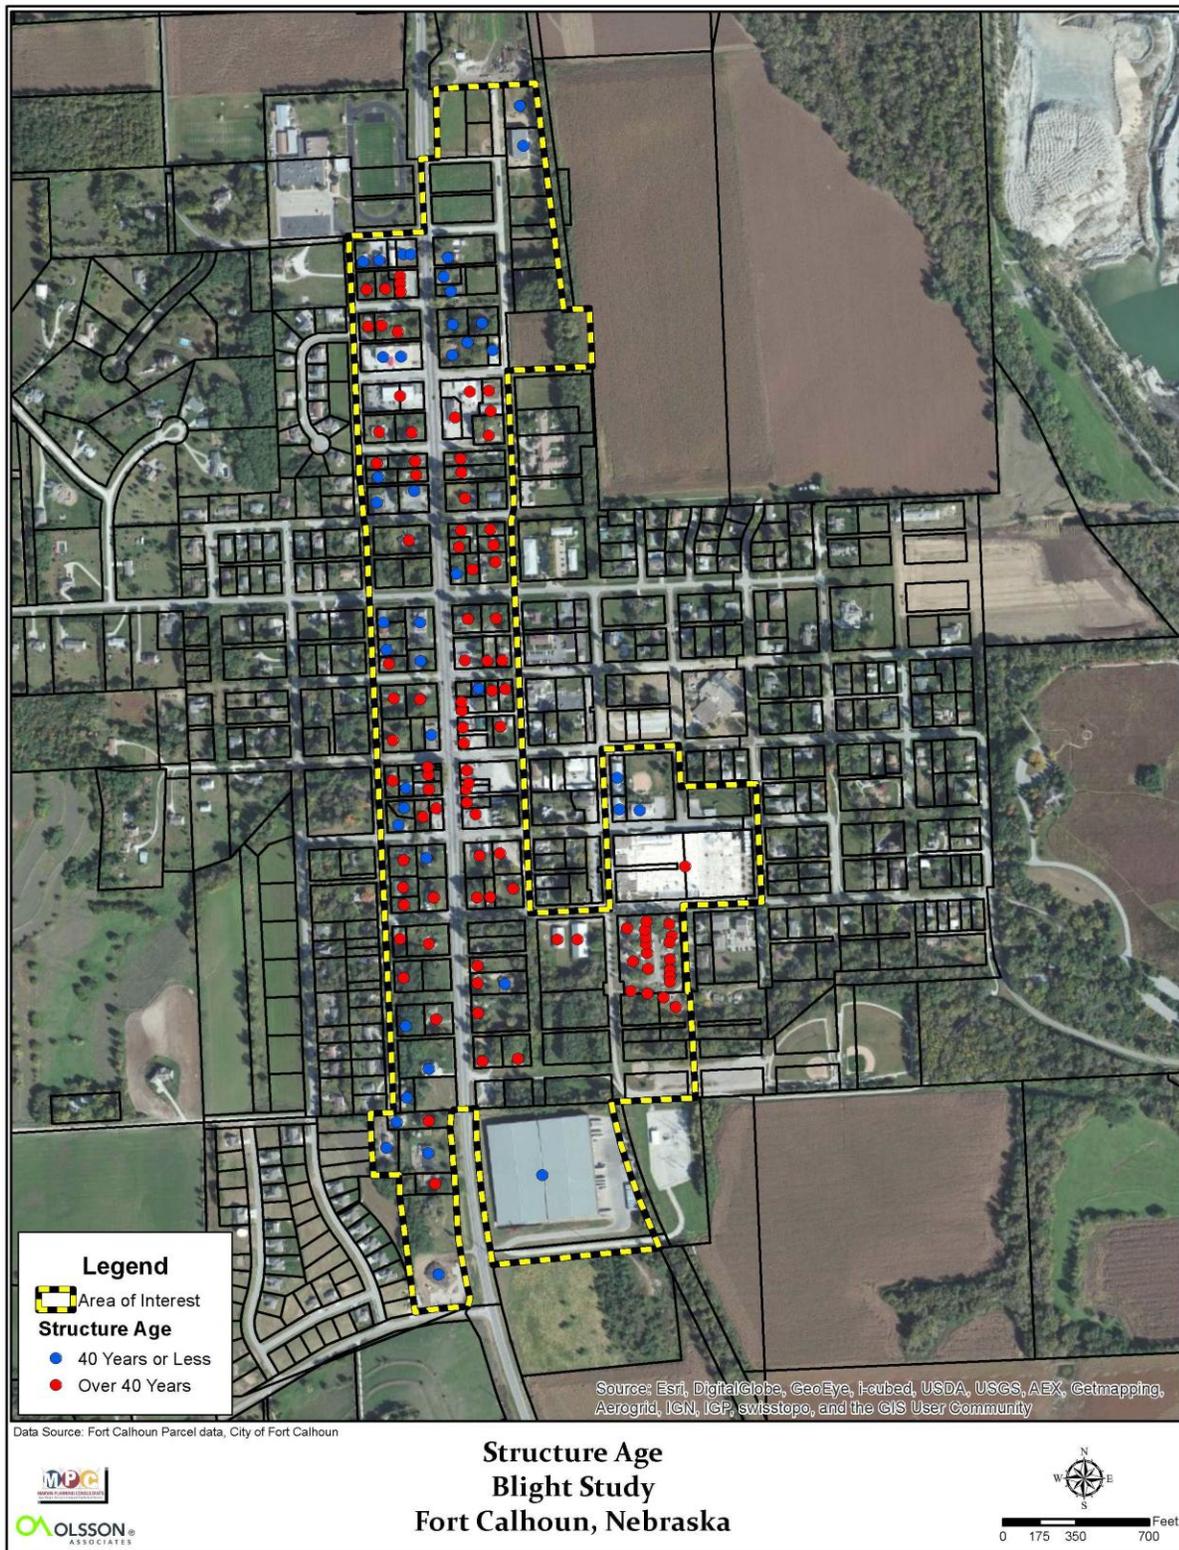
Figure 3
Unit Age Map

Within the study area there is a total of 140 structures. The following breakdown is the breakdown by age grouping:

- 98 (70.0%) units were determined to be 40 years of age or older
- 42 (30.0%) were newer than 40 years.

Based upon this data, the age of the structures is a direct contributing factor.

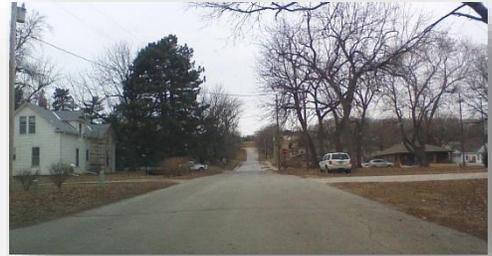
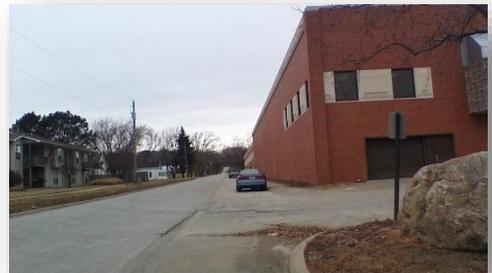
Deteriorating is defined as any evidence of breakage/chipping, heaving, major potholes, spawling finished surface, and materials lose at joints.

- 6,660 (30.5%) lineal feet of adequate street
- 12,797 (58.6%) lineal feet of deteriorating street
- 2,385 (10.9%) lineal feet of platted but unopened streets.

The study area has 69.5% of the streets are in either a deteriorating state or they are platted and unopened. See Figure 6 for the locations of these streets.

The photos to the immediate right shows some of the deteriorating conditions found within the study area.

Due to the large amount of deteriorating or platted and unopened street, the street conditions are a direct contributing factor.

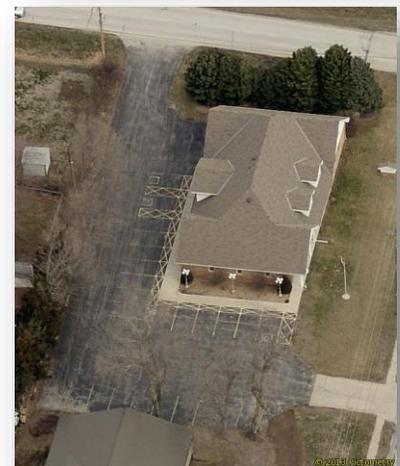
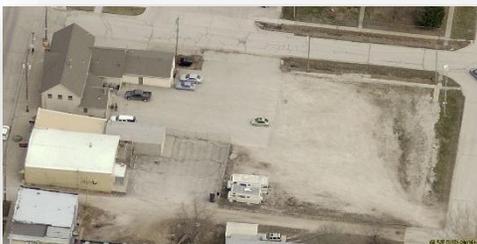
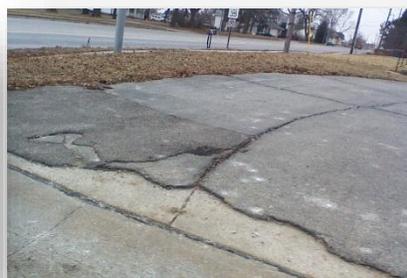
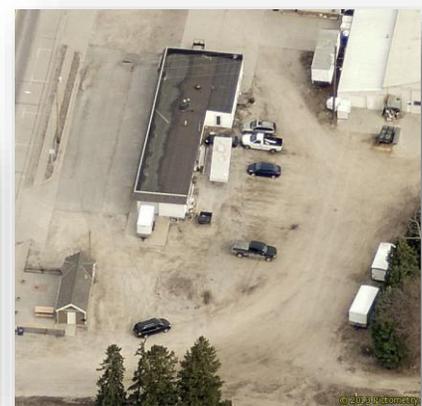
A large portion of the properties have gravel/dirt drives and parking lots. These properties create several issues within a community including:

- Dust conditions during dry periods
- Ruts from heavy equipment
- Water holes during wet periods

Some properties have paved/improved parking areas and drives were found to be in a state of deterioration. Several of the hard surfaced lots, as seen on the right are in considerably poor condition.

Based upon the field analysis, there are sufficient elements present to meet the definition of deterioration of site and other improvements in the Study Area.

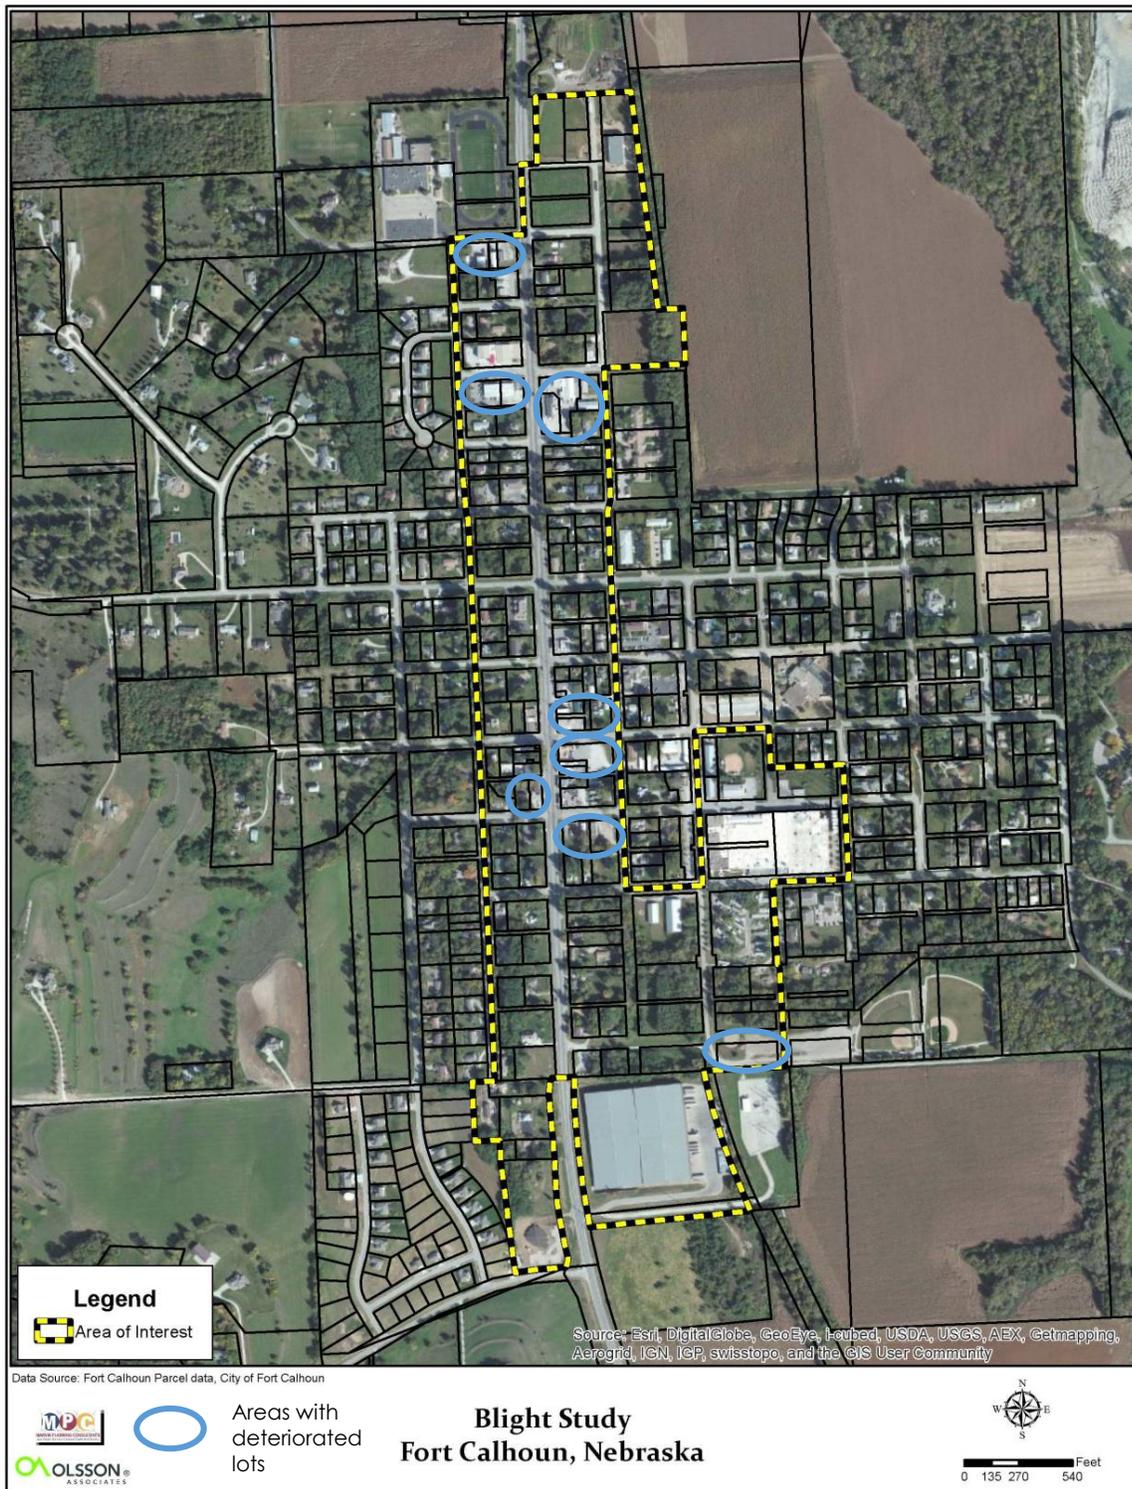
Figure 7
Site Improvement Conditions

Figures 7 identify the different properties in the study area that have deteriorating parking areas and drives, as well as those properties that have been hard surfaced and are showing signs of deteriorating and in need of repair/rehabilitation. Even though most of the land uses in this area are heavier commercial to industrial uses, the lack of hard surfacing or the deterioration of the existing hard surfacing has a major impact on the perception of the area as well as the value of the area.

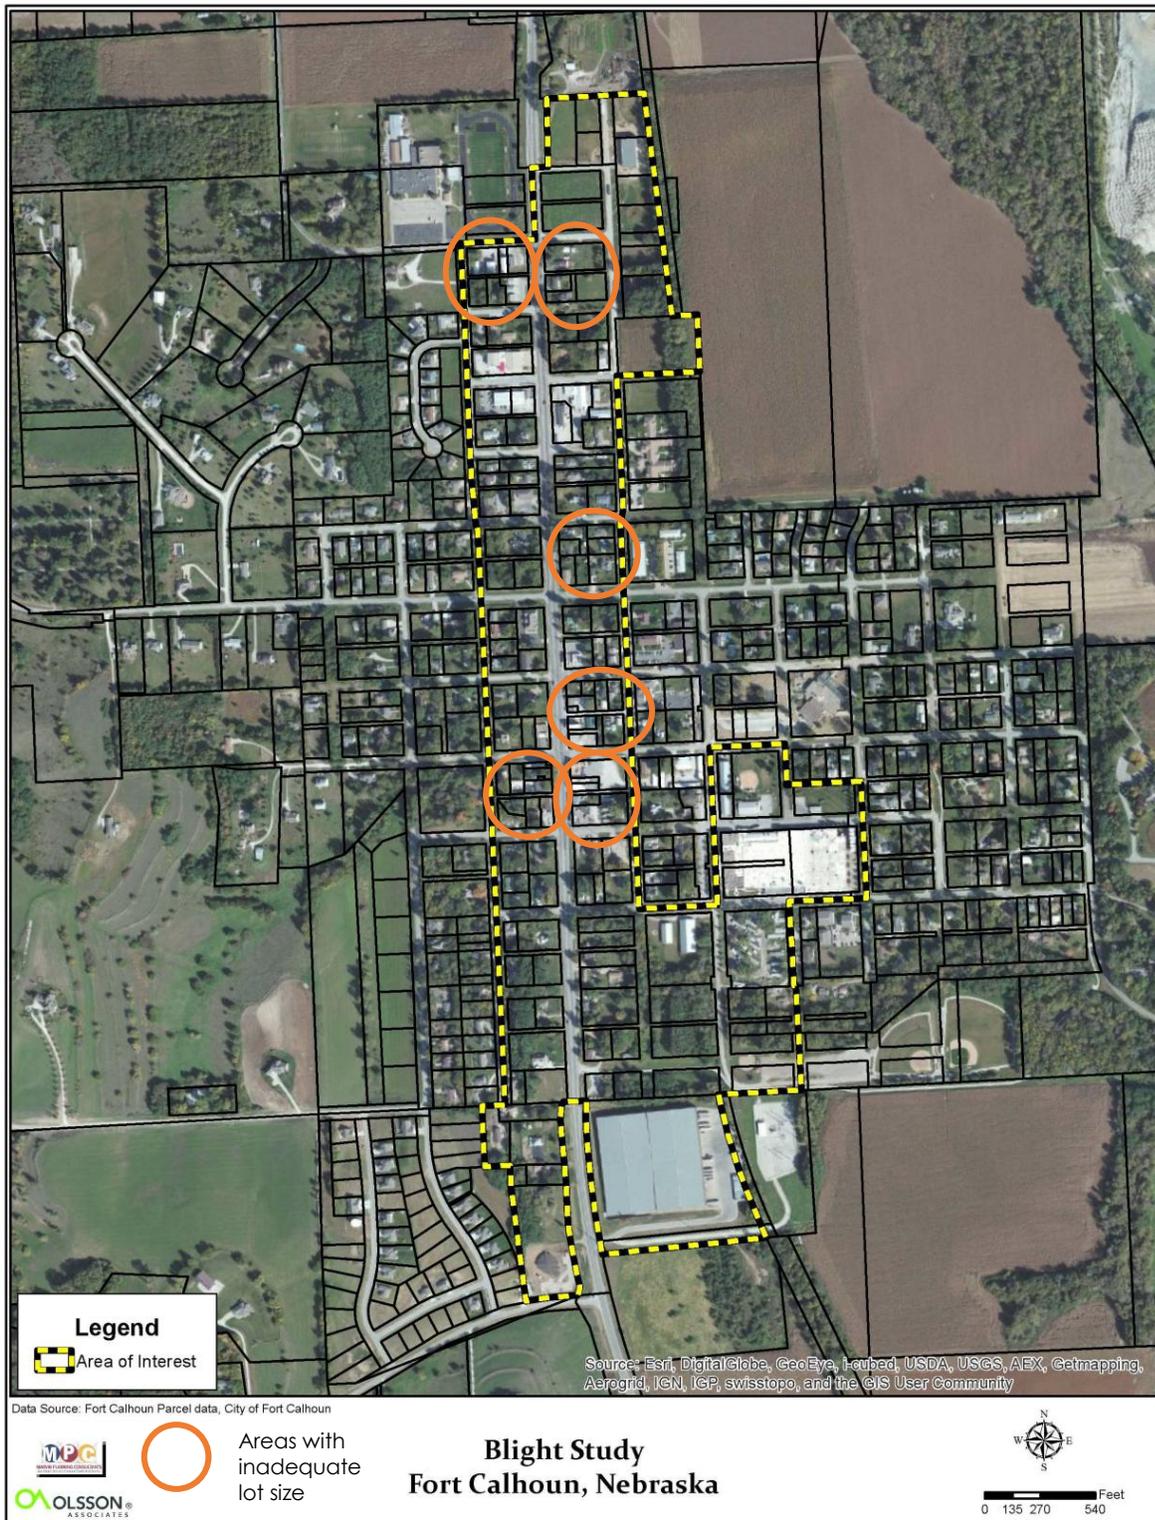
Figure 8
Faulty Lot Layout Conditions

Based upon the discussion regarding lot size and shape above, the lots in Figure 8 are not adequate for the type of land use and zoning designated for this area. Parking and deliveries opportunities are somewhat limited on these lots. In some cases, the actual shape and layout of the lot can create issues with future construction and redevelopment of the site.
